“Made in the U.S.A.” Audio Component Pioneer Redesigns Efficiency

Elastomeric Polymer-Based Surface Enhancement Coating From Magnaplate Doubles Coil Winding Efficiency And Reduces Rejects 75% For Pyle Industries.

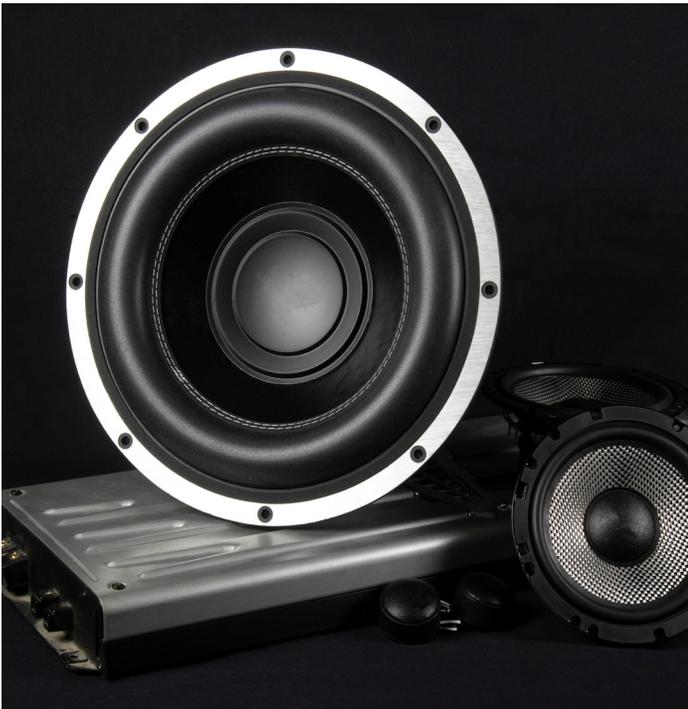
The manufacturing process works like this: The polyimide film (a thermoplastic sheet of three or five mils thickness) foundation of the voice coil is wrapped around a 6061-T6 aluminum arbor, which ranges in size from 3/4" up to 3". Insulated magnet wire coated with a proprietary adhesive system is then wound wet on the arbor. When the winding is completed, it is aligned and reinforcing tape added to the coil.

The coils are baked at about 400°F for 40 minutes. Following the baking, the coil lead wires are chemically stripped and solder tinned. At this point the coils are removed from the arbors and the arbors recycled back to the beginning of the wet winding process.
